Avista™ Membrane Autopsy

Membrane Foulant Identification

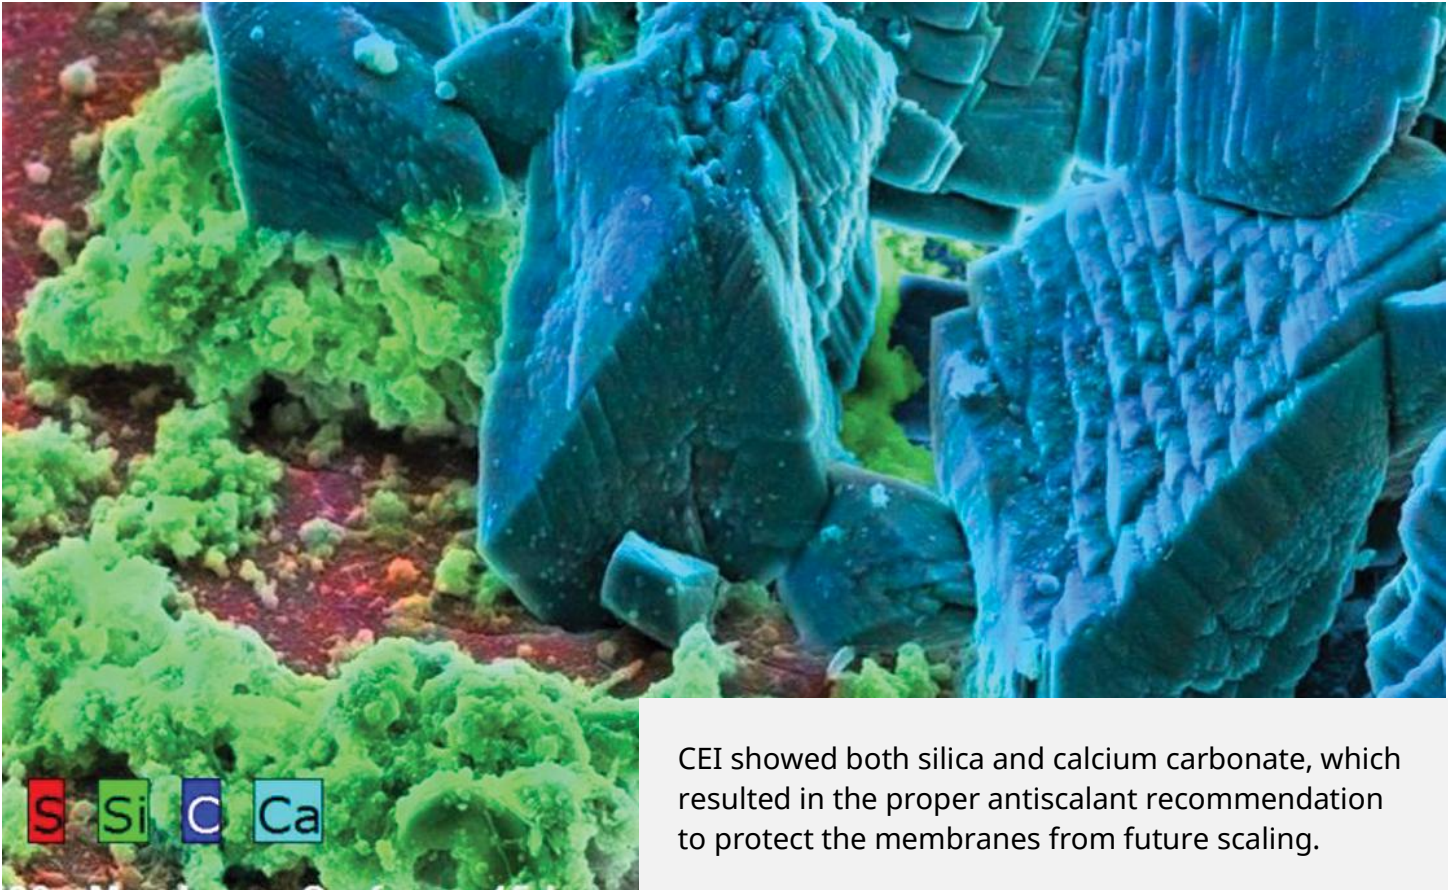
CEI showed both silica and calcium carbonate, which resulted in the proper antiscalant recommendation to protect the membranes from future scaling.

Additionally, it provided information on a cleaning sequence that removed the calcium carbonate layer first, followed by the silica scale.

- The tail element weighed almost 50 pounds (22 kgs) more than a new element, a clear indication of severe scaling.
- The Avista membrane autopsy revealed crystals on the membrane surface.
- CEI identified the crystals as calcium carbonate scale layered on top of silica deposits.

Based on a review of an original feedwater analysis, the Avista membrane autopsy determined that both calcium carbonate and silica were within the inhibition capabilities of the on-line antiscalant.

- The antiscalant injection rate was correct, and the system recovery was within design parameters.
- A new feedwater analysis was completed and revealed that the silica values had doubled over the summer.
- The higher silica values exceeded the capabilities of the scale inhibitor, which led to the extreme scaling.
